Manhole Inspection Summary

Manhole # S43I__033MH

Location Address: **309 unnamed alley**

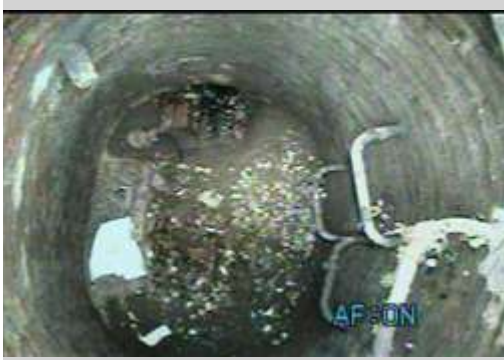
Defect 4

Condition: ☐ Sound ☐ Cracked ☐ Root Intrusion ☐ Deteriorated ☐ Leaks ☒ Debris

Channel Debris

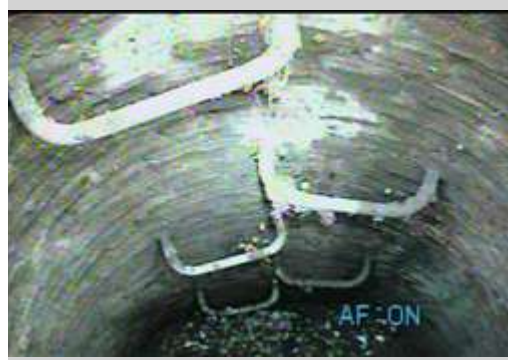
Defect 3

Steps Count: **5** Missing: **0** ☒ Corroded

corroded steps

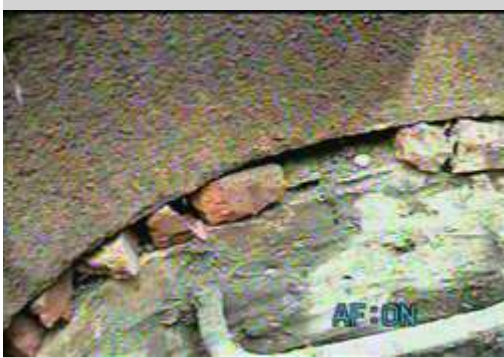
Defect 2

Condition: ☐ Sound ☐ Cracked ☐ Root Intrusion ☒ Loose Brick ☒ Deteriorated

loose brick and deteriorated chimney,
frame adjustment

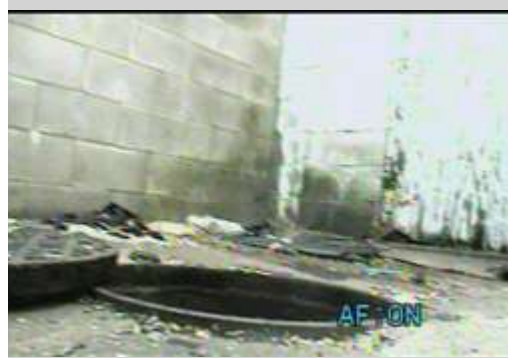
Defect 1

Cover Shape: **Circular** Diameter: **26** (in.) Length: **0** (in.) Dist A/B Grade: **1.5** (in.)

above grade
